## **Water Ingress Failure Analysis of Whistler II Unit**

**ARL-TN-0623**

**August 2014**

**Sensors and Electron Devices Directorate, ARL**

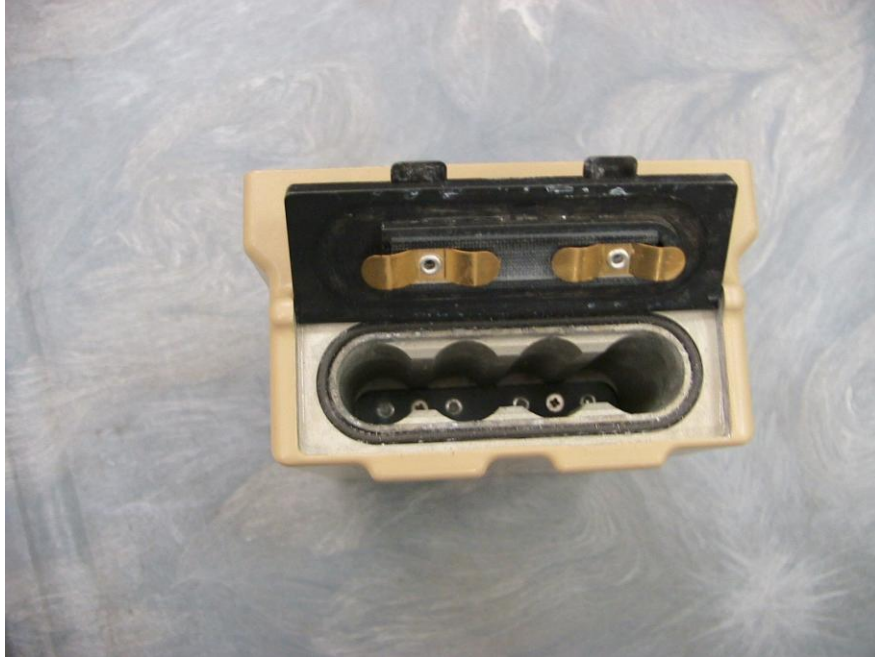
We found significant moisture present in the battery compartment (Fig. 1).

- a. The O-ring seal was intact.
- b. White powdery residue was present on aluminum surfaces consistent with aluminum corrosion. All aluminum surfaces were chromate conversion coated and should not have been subject to corrosion with exposure to ordinary rain water. The batteries were highly corroded, and some chemicals likely leaked out. Due to the inherent corrosive nature of these chemicals, there dispersion in the water that was present is the most likely explanation of the high level of corrosion seen on the aluminum. Also, the possible shorting of the batteries through the moisture on the compartment surfaces could have aggravated the corrosion. A final contributor could be that the passivation process was done poorly.

Fig. 1 Battery compartment (battery door open)

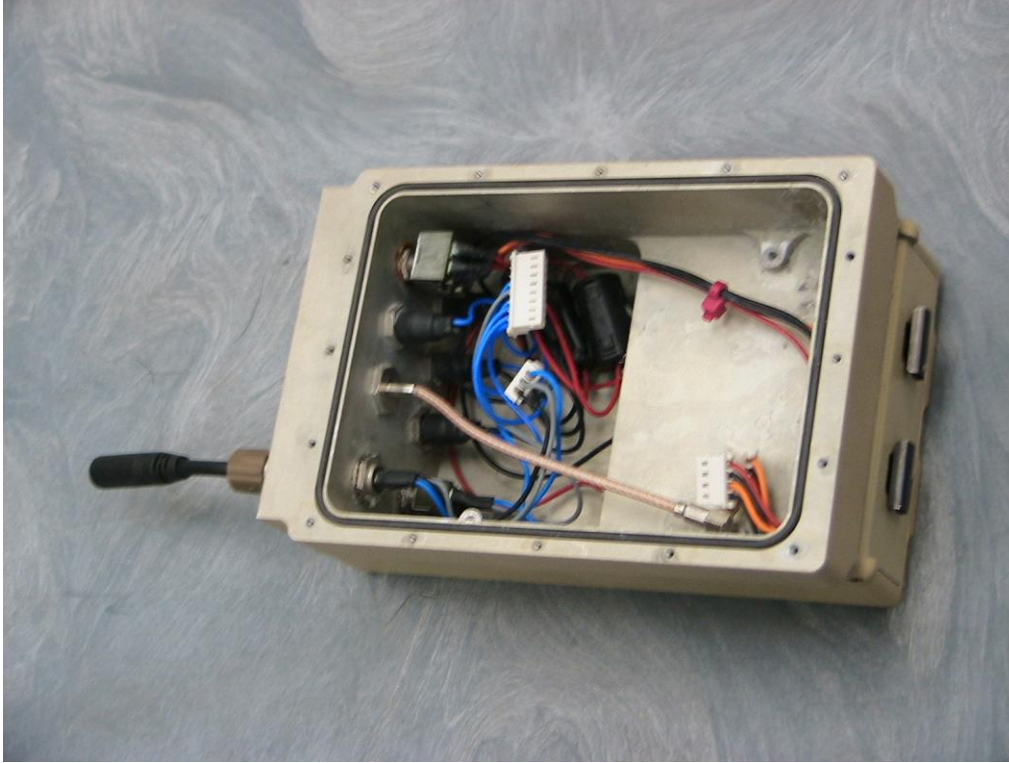
We found significant moisture present in the electronics compartment (Fig. 2).

- a. The O-ring seal was intact.
- b. White residue was present on many of the solder joints. Per Art Harrison, this is consistent with exposure of solder flux to moisture.

- c. Corrosion was present in the cavity. Most, if not all, of the corrosion present in the electronics compartment appears to be attributable to water, possibly ionized, present at dissimilar metal interfaces, thus forming a galvanic reaction. White powdery residue was present on some of the aluminum surfaces consistent with aluminum corrosion; however, it was not as prolific as in the battery compartment and in most cases could be wiped off without evidence of damage to the surface, indicating that this residue was likely from localized sources and redeposited on noncorroded faces. Orange-Brown residue was present on the star washers of both switches, consistent with corrosion of steel (rust). The material of the star washers is zinc-plated steel/chromate conversion coated. Corrosion of the star washers was greater than would be expected by normal rain water at normal temperatures. Limited orange-brown residue was present on the steel shield compartment on the audio board, consistent with the corrosion of steel (rust).

Fig. 2 Electronics compartment (electronics removed)

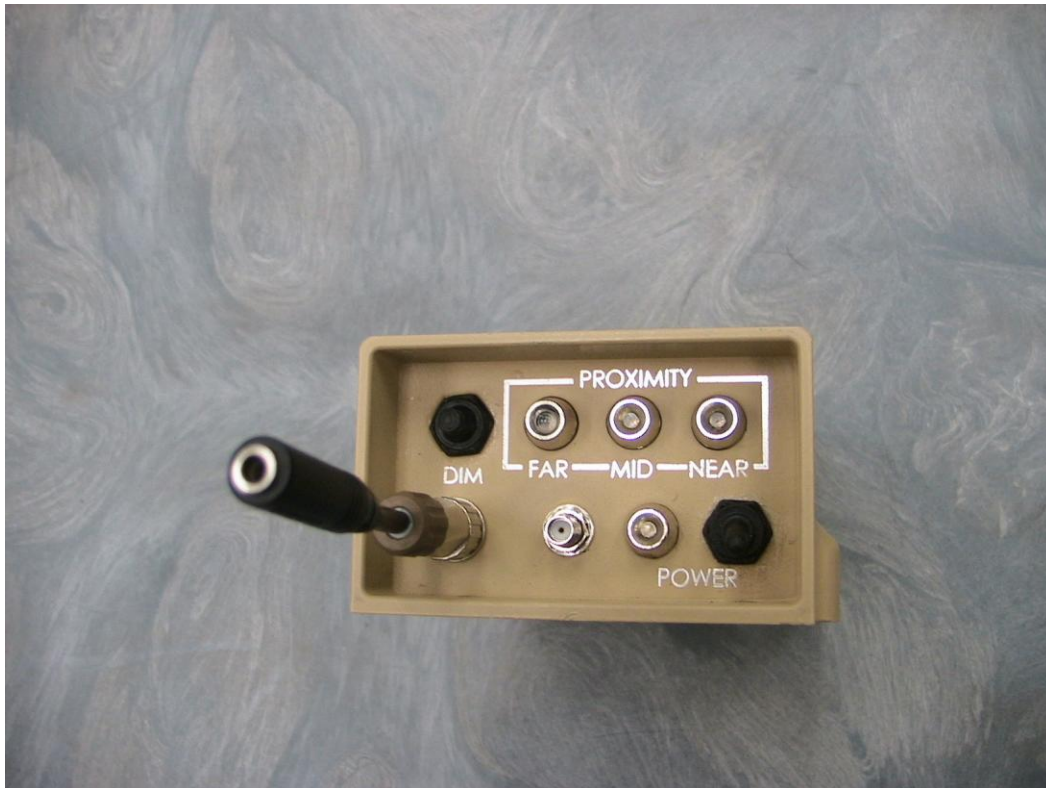
Fig. 3 External view, showing interface components

**c. Primary Test 1a. Rain Test Equivalent - Normal Configuration (see Fig. 3)**

The top of the unit was filled with tap water and carefully examined for bubble formation for 30 min. None could be detected. This amount of water—5/8 in—would apply a very low pressure; however, it is the worst case in the ATEC rain test. After removing the water, the electrical compartment cover was removed and there was *no moisture present in the electrical compartment*. As expected, there was no moisture present in the battery compartment (since there was no water in the electrical compartment and there was no significant external exposure to water at the battery compartment door).

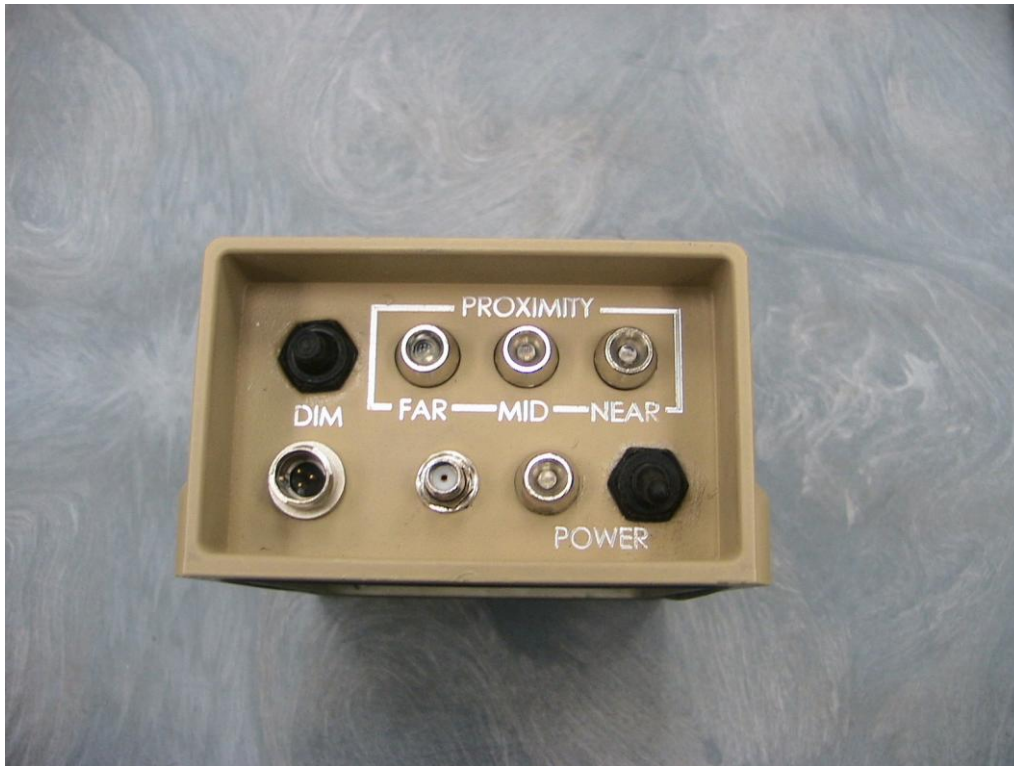
Fig. 4 Configuration for Excursion Tests (audio adaptor detached---not normal configuration)

- i. The unit was observed for bubble formation for 30 min. *Bubbling/leaking was detected intermittently at the audio connector electrical mating interface (audio receptacle).* Although intermittent, the quantity of bubbles released at each event was substantial. Note that the leak did not occur at the audio connector to bulkhead interface where the component's seal is, but "through" the connector, itself. Also of significant note, even though there was substantial water in the electrical compartment, *there was no trace of water in the battery compartment*; this would indicate that the RTV sealant at the holes between the two compartments did not fail, properly isolating moisture between the compartments.

We believe that there were flaws with the ATEC testing; regardless, certain vulnerabilities were discovered that should be addressed in the next Whistler design iteration. Based on our testing, we can surmise that ATEC tested the unit(s) without the audio adaptor cable in place, although this is not the normal configuration. The manufacture’s specification for the audio connection is that its protection from water ingress is well above our requirements with an Ingress Protection Marking of 68, based on IEC standard 60529 when the Plug and Receptacle are mated. However, a specification for the unmated condition is not given. Although the normal configuration is that the connectors are always mated, we should consider that the Whistler unit could be exposed to the unmated condition in the field. This being the case, it is recommended that the current audio connector pair be replaced with one that clearly specifies protection from water ingress in both mated and unmated configurations. Based on our testing, we also believe that the battery door was not fully closed/latched during the ATEC testing. We now believe that the design of the
